Toothed Belt

Timing/Driving Belts for your industry:

Troubleshooting Examples of V-Belt & Timing Belt

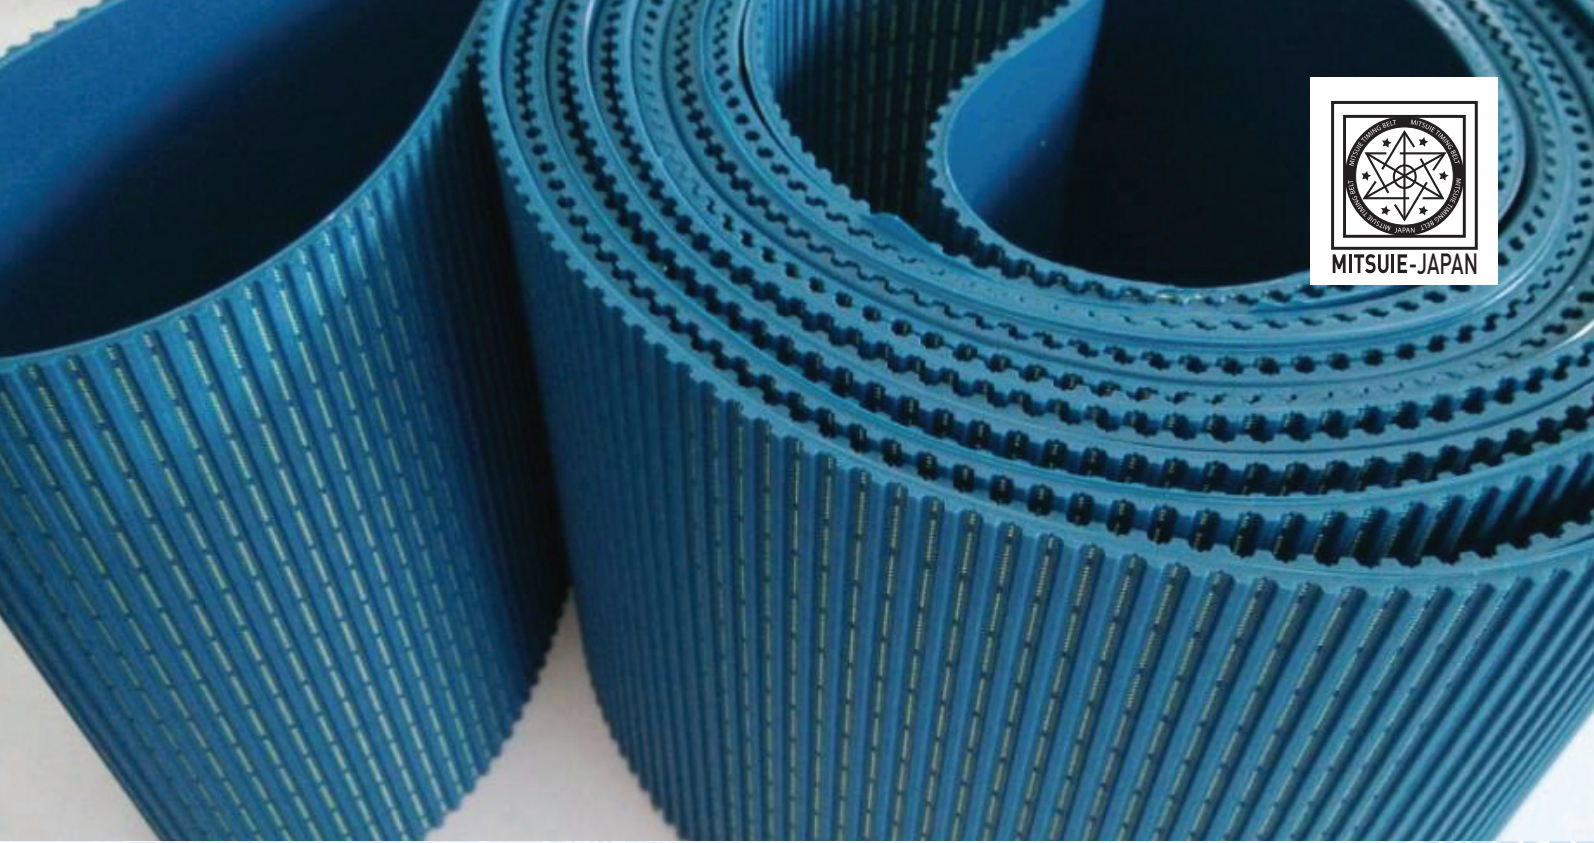
Endless loop, no join type construction for unbeatable tensile strength

This toothed belt is designed to provide a constant, synchronised, slip-free drive to all the yarn feeders on the feeder ring. The endless loop construction means that the belt has no bonding join. The belt has a very strong tension cord with 11 windings. These two features means that the belt has an excellent tensile strength along its entire length. There are no weak spots. Belt materials and construction method have proved to be the only way to produce a high quality belt which guarantees smooth, trouble-free running and a very long service life.

Endless loop type with one tensioner cord in 11 windings.

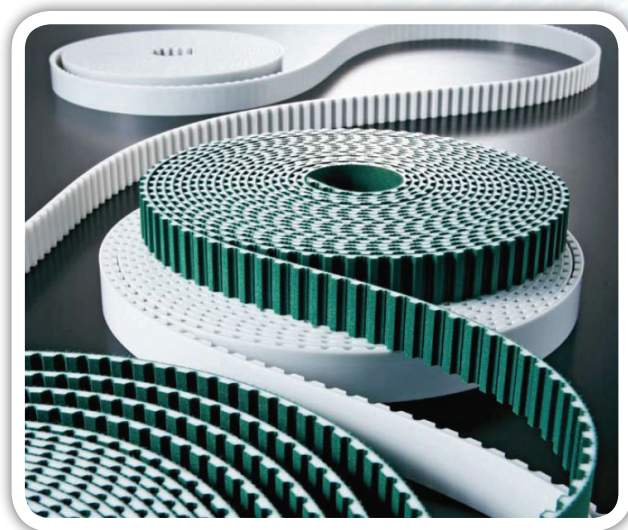
OPTIBELT's original timing belt engineered and manufactured to exceed expectations. It starts with the fiberglass cords that efficiently transmits more power where you need it. The cords are counter wound for smooth, non-biased running. The durable rubber impregnated polyimide fabric increases durability and oil resistance is bonded to the engineered natural & synthetic rubber core. Fits standard HTD® and RPP® pulleys so you get more performance and durability without the need to replace existing pulleys.

- Oil resistant top layer fabric
- Polychloroprene rubber core
- Glass fiber tension cords
- Reinforced polyamide tooth cover

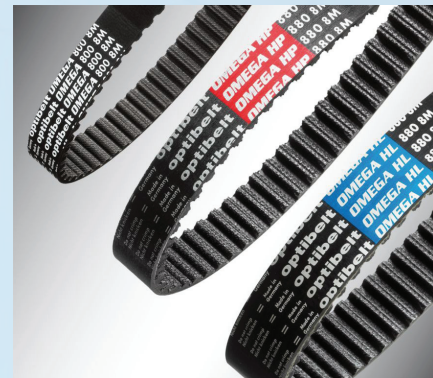
OPTIBELT V-Belts are manufactured with carefully chosen raw materials and by using continually updated manufacturing methods. With modern production processes, large scale laboratory testing, and carefully controlled quality, OPTIBELT produces an ideal V-belt for every power transmission requirement with function, efficiency and durability exceeding any competitor's product.

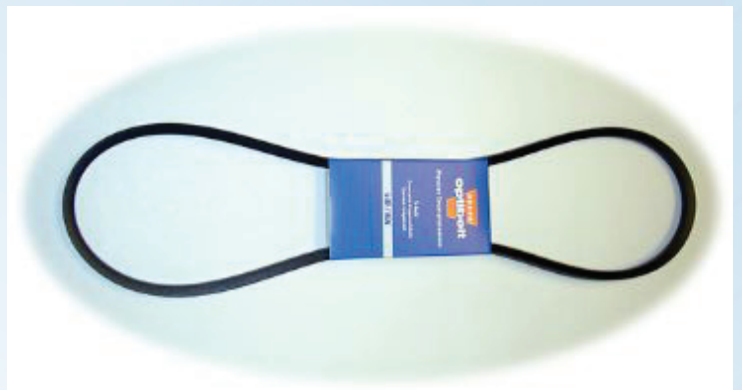
Maintenance-Free, High-Capacity, Wedge Belts This second generation of V-belts produces results that are really worth talking about: **up to 42% more power** while at the same time **cutting costs by up to 20%**. Improved production processes and consistent development of basic products have led to these excellent results. The cost savings are

explained with the following formula: **Fewer belts + narrower pulleys + saving in drive space = lower costs.**

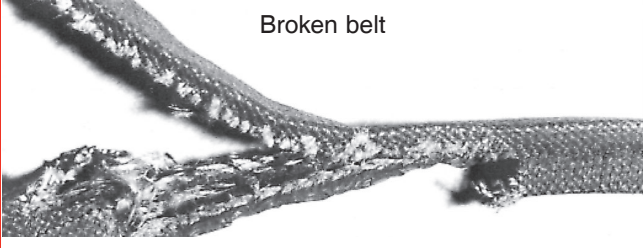
<p>Broken belt</p>	Foreign object in drive	Shield drive

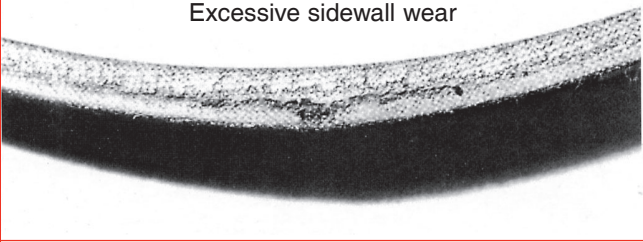
<p>Excessive sidewall wear</p>	Worn or damaged sheaves	Replace sheaves

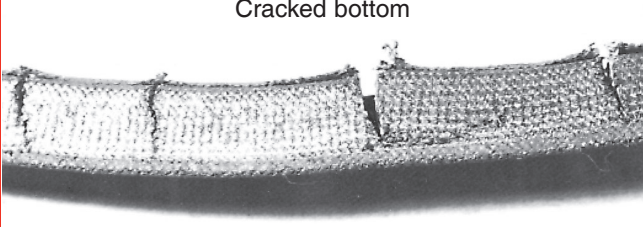
<p>Cracked bottom</p>	Sheave diameter too small Back side idler diameter too small Slippage High temperature	Redesign drive Replace with an inside idler on slack side, or redesign Retension drive Remove heat source. Improve ventilation

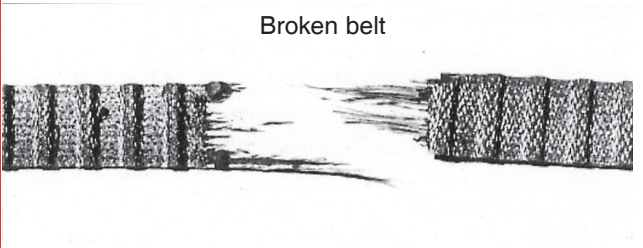
<p>Broken belt</p>	Underdesigned drive Crimp caused tensile cord damage Belt was pried or forced on the drive Foreign object in drive Belt ran onto pulley flange	Redesign drive Follow proper storage and handling procedures Follow proper installation guidelines Shield drive Align pulleys

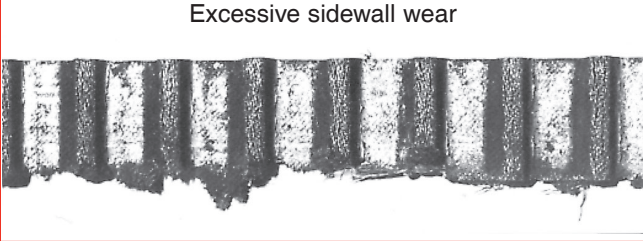
<p>Excessive sidewall wear</p>	Misalignment or non-rigid centers Bent flange	Align drive and/or reinforce mounting Straighten flange

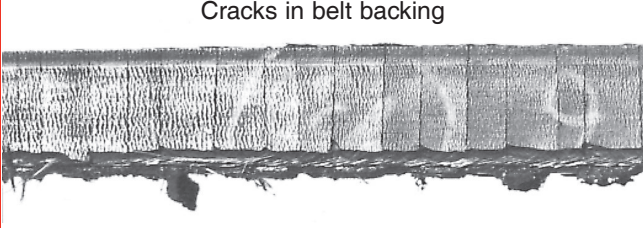
<p>Cracks in belt backing</p>	High temperatures	Remove heat source. Improve ventilation. Check for special belt construction
